Stewart Meadows Habitat Assessment & Conceptual Design

Rio Arriba County, New Mexico

PROJECT PHASE: 70% Design Plans

DRAWING:
Upstream Project Area
Assessment Overview

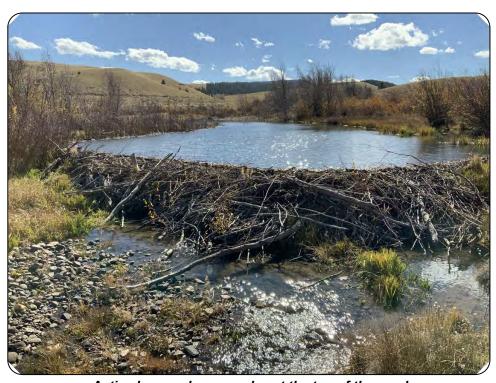
Reference condition Inner berm reach

Active beaver dam complex at the top of the reach, immediately downstream from the boundary fence.

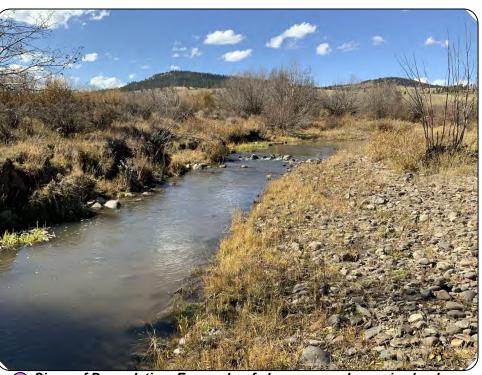
1 Signs of Degradation. Excess hoof sheer on sandy erosive banks, trampling of deposited fines limiting colonization by wetland species, biofilm, high w/d ratio

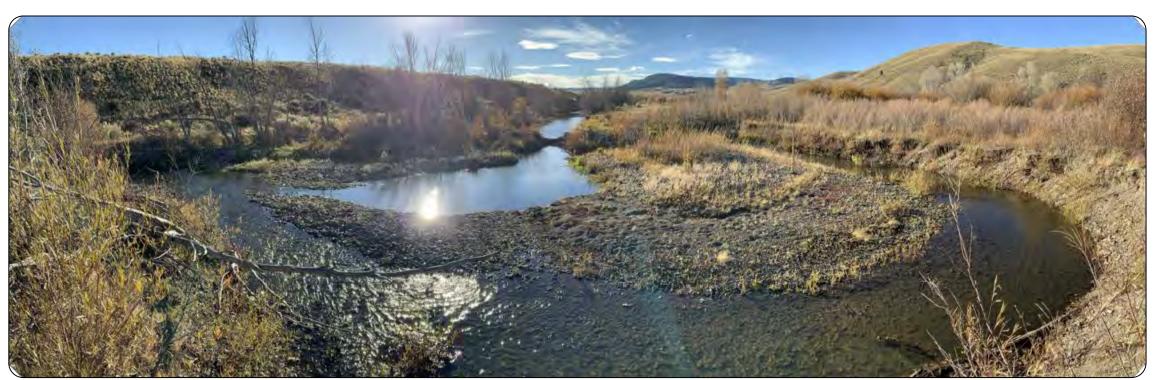
Breached beaver dam with mid channel depositional bar located near a proposed channel plug and excavated leadout channel location. The low energy geomorphology of this location lends itself well for sending flows onto the adjacent flood channels and floodplain with the use of an earthen channel plug.

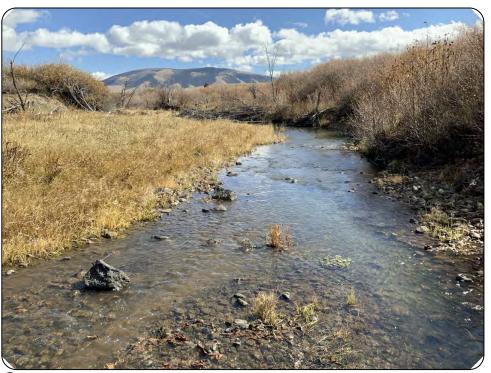
20 Slightly entrenched reach with high w/d ratio, numerous bars, poor shading, small woody debris jams in a former beaver dam backwater

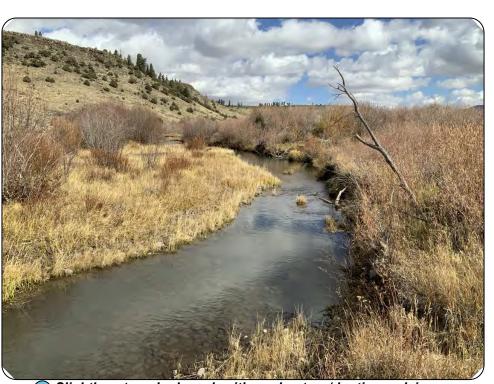
23 Slightly entrenched reach with moderate w/d ratio, evolving meanders and unconsolidated alluvial bank material

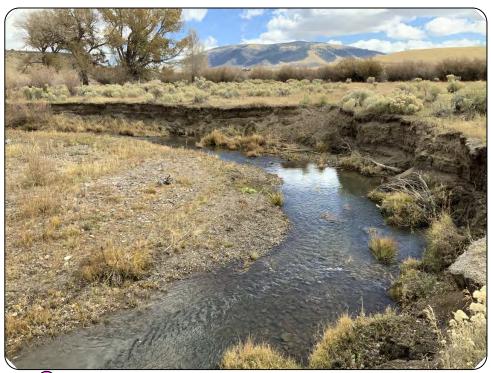
Reference condition Spawning gravel deposited below breached beaver dam
