# Rio de Las Vacas Riparian Restoration

Rio de las Vacas Design  
&  
Tributary Concept Design and Assessment

The section of the Rio de las Vacas between the FS 20 road crossing upstream to the private land boundary was assessed geospatially and surveyed on foot. An 80% design is included in this report for the section, which includes structure types and locations, recommended enclosure realignment, alluvial fan resets, and planting areas with complex objectives and anticipated zone of influence. The remainder of the tributaries and sections of the mainstem Rio de las Vacas were strictly assessed geospatially and verified through cross-checking with the Rio de las Vacas assessment report from 2021 (Whittlesey 2021), with the result being high-level concept designs.

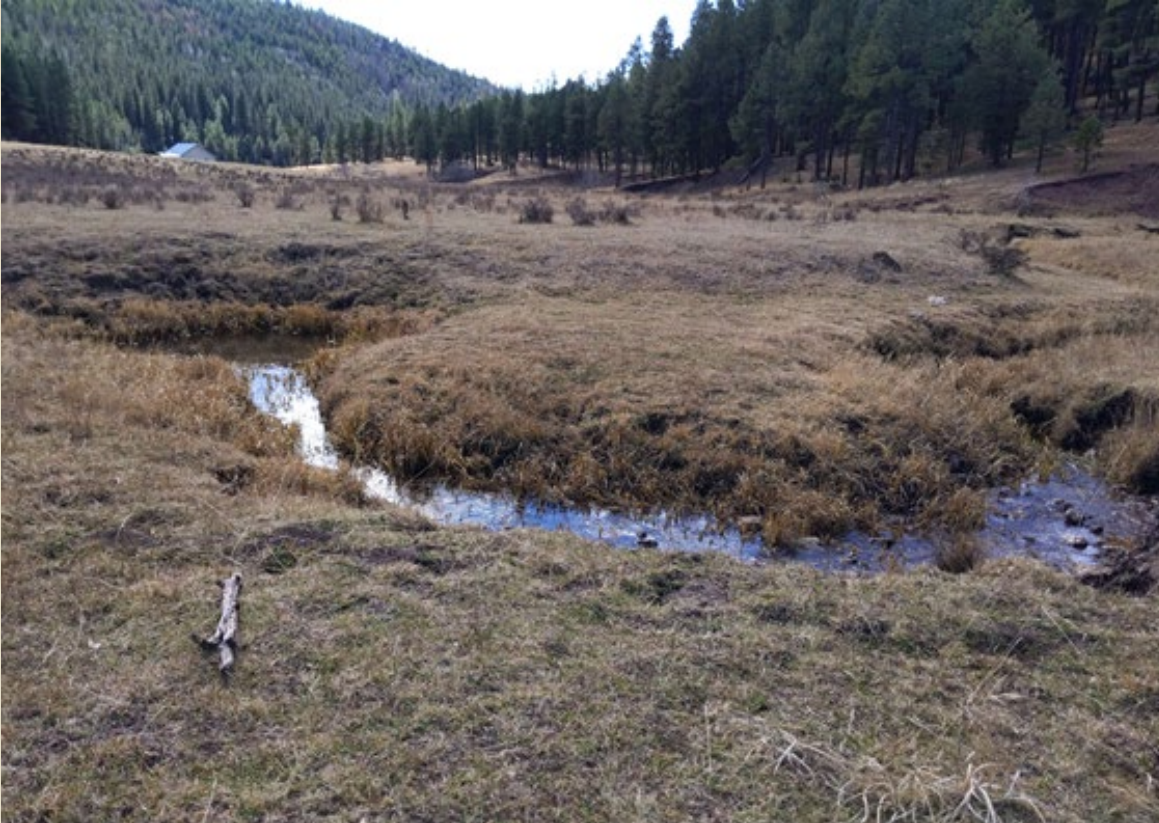
Limited Riparian  
Vegetation

Incised channels

Disconnected from  
floodplain

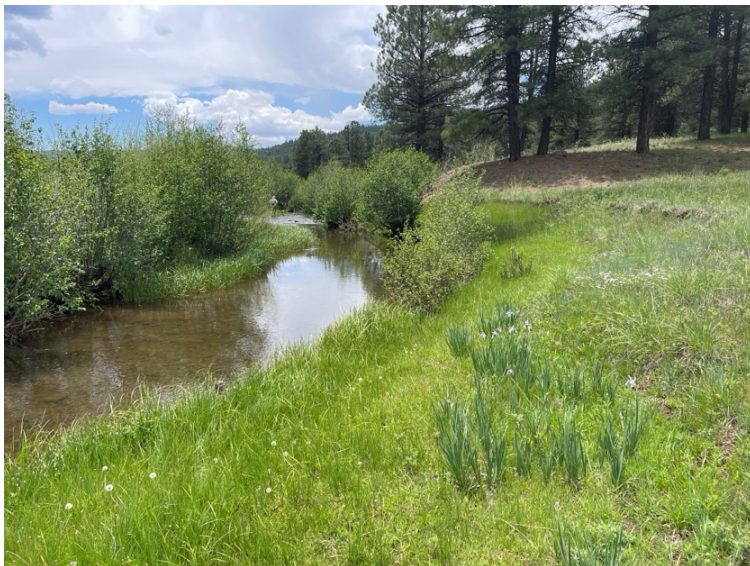
*Figure 5. An entrenched reach within the Rio de las Vacas project area. Note the inset floodplain and limited riparian wetland width. In-channel complexity is limited.*

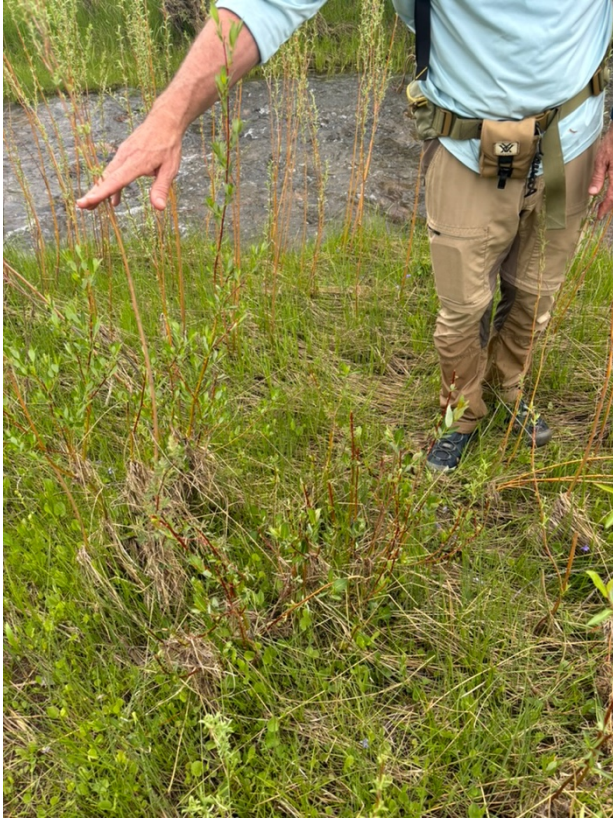
Elk exclosures are recommended due to evidence of high browse pressure within areas excluded from cattle. In the absence of wolves, elk browse pressure can exceed the tolerance of willow, either leading to long-term stunting or local extirpation. Willow outside of elk exclosures but within livestock exclusionary fences were observed to be experiencing sufficient levels of elk browse to inhibit growth to a mature, within the Red Top and Telephone Canyon reaches.

Figure 7. Elk-browsed willow plantings.

Currently there are 11 elk exclosures within the project area between 1-4 acres in size. Few of them include the entire historic floodplain. The recommended course of action is to remove the existing exclosures and realign them to span the historic floodplain, reducing the total number of exclosures but increasing the size. Larger exclosures are less of an impediment to wildlife and recreational access and are visually less disruptive to the viewshed. Exclosures will be built with gates

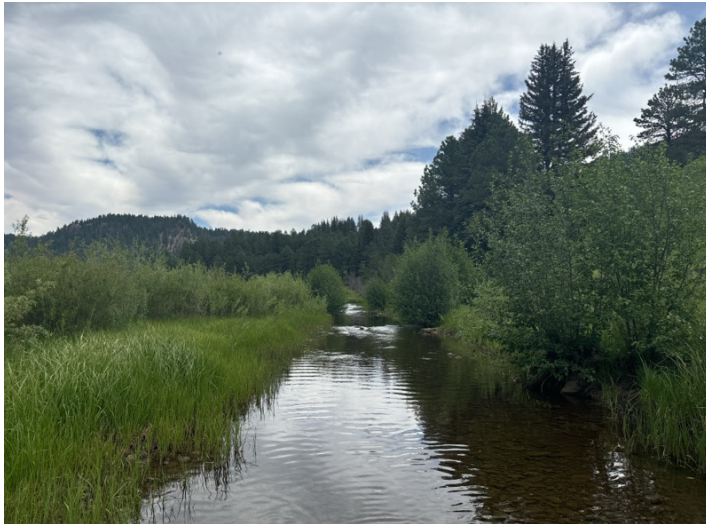
Figure 8. An overly simplified and linear stretch of the Rio de Las Vacas

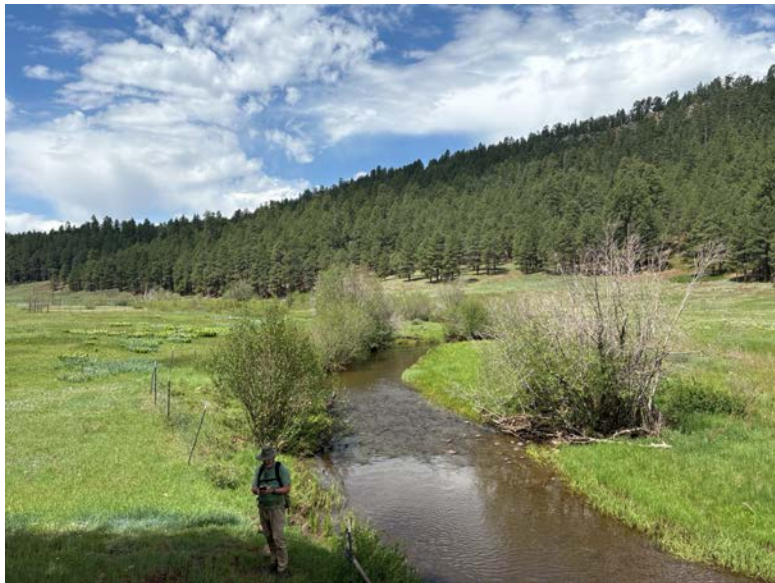
*Figure 10. A representative photo of the Telephone Canyon Reach on the Rio de las Vacas within the project area. The stream is lacking habitat complexity and is largely disengaged from the historic floodplain, with a reduced riparian wetland and limited willow.*

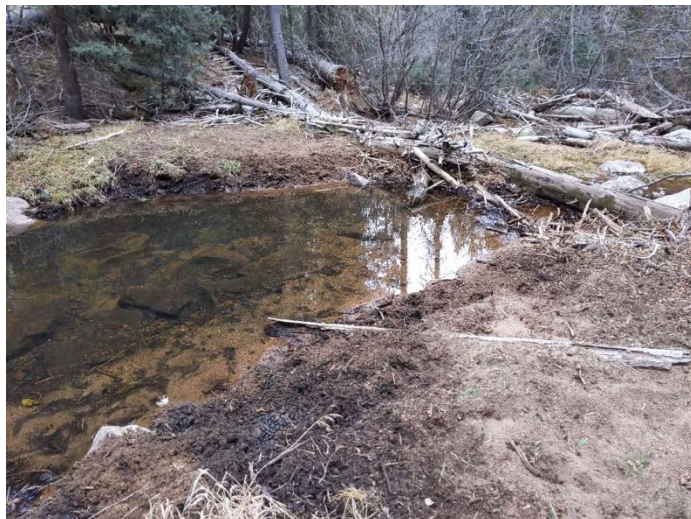
*Figure 12. A woody debris jam creating pooling habitat on the upper Rio de las Vacas. Extensive hoof shear and browse are reducing function.*

Segments of the stream in this reach would benefit from increased pooling, floodplain connectivity (where floodplains are found in the confined channel), and increased channel complexity, particularly in side-channel development and anabranching.

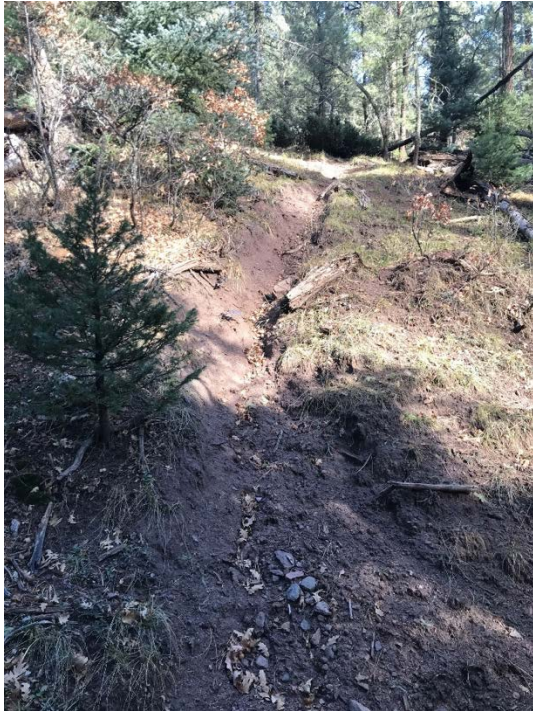
*Figure 13. Cattle and elk trailing causing erosion and contributing to sediment inputs to Rito de las Palomas*

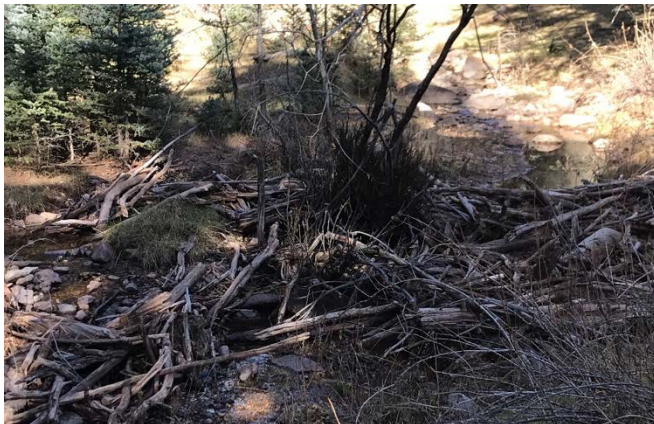
*Figure 14. Woody debris racking on Rito de las Palomas. Note minimal coverage of willow suggestive of high cattle and elk browse pressure.*

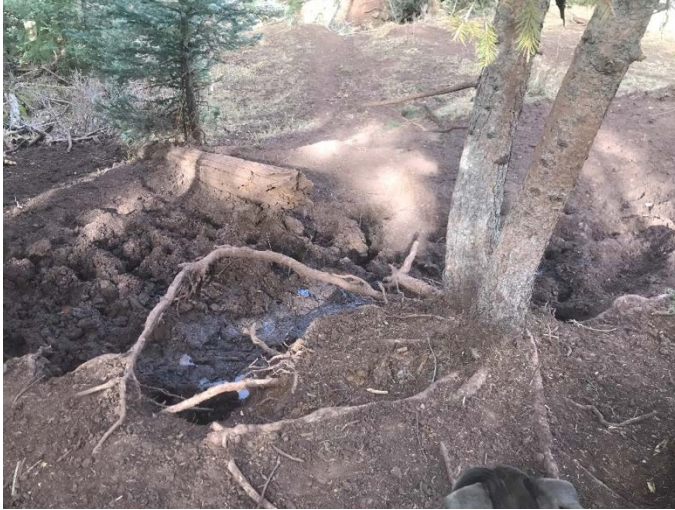
Figure 15. A heavily degraded perennial spring on Rito de las Palomas

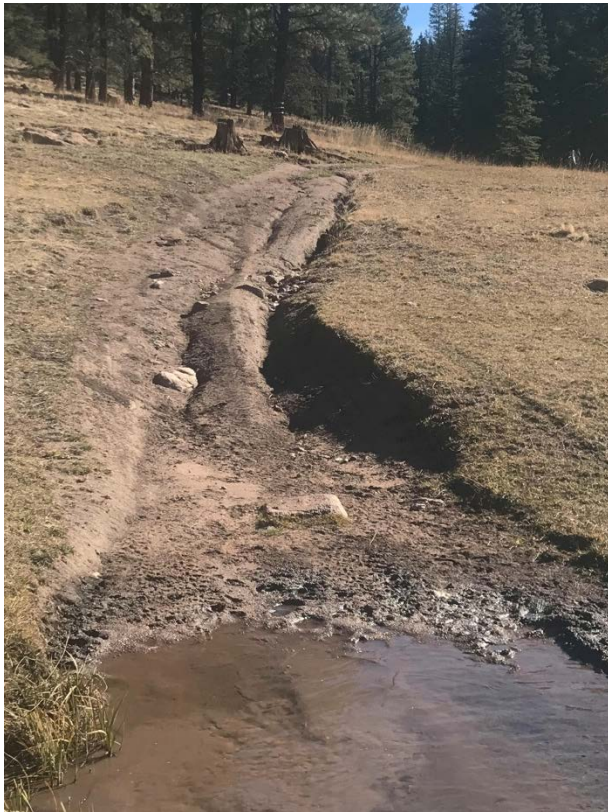
Figure 16. An eroding road crossing contributing sediment into American Creek. Throughout much of the lower reach a non-system user created road parallels the channel.

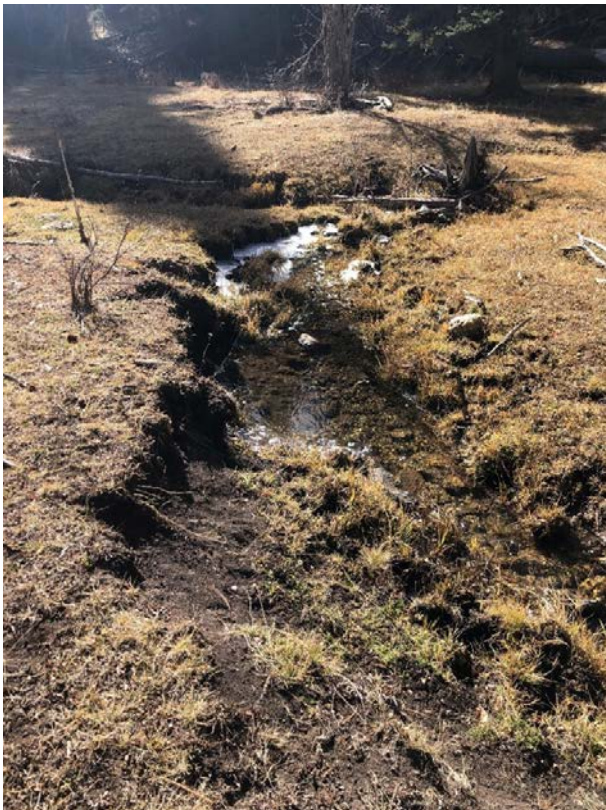
*Figure 16. Hoof shear impacting bank stability and browse pressure reducing shading and woody riparian vegetation on the Rito Café.*

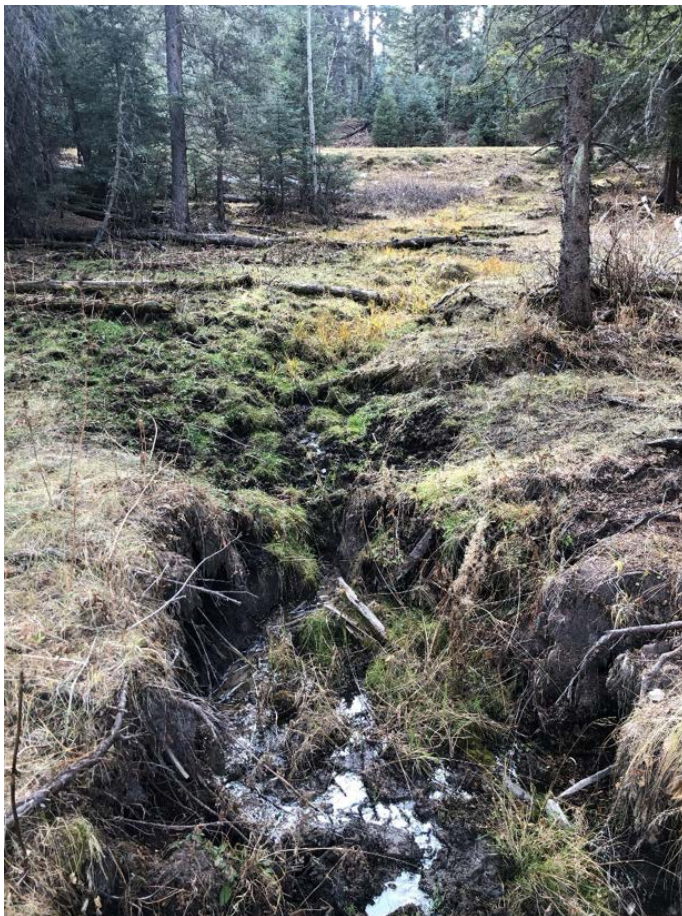
*Figure 17. Upstream of the beaver dominated reach on the Rito Luterio, the stream becomes more degraded. An active headcut is seen here, downcutting through a spring-fed slope wetland.*

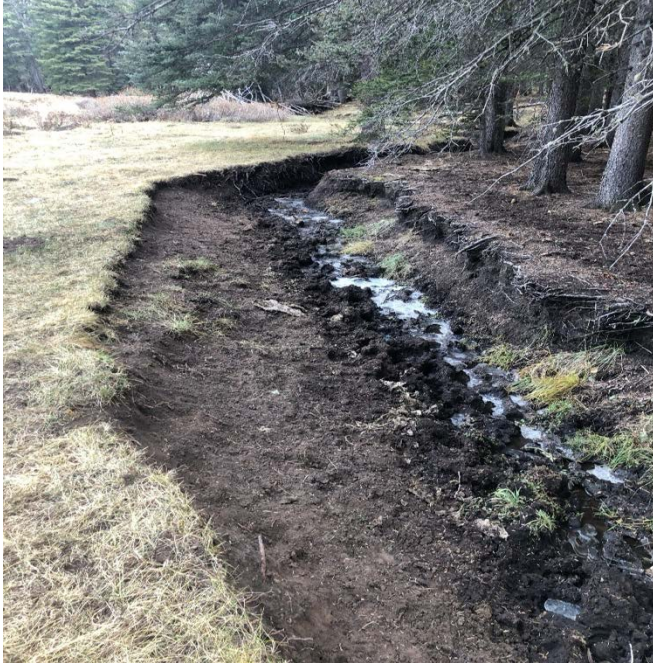
*Figure 18. Near Luterio Spring and the Valle Luterio, the channel is actively eroding. A historic slope wetland, or wet meadow is becoming an ephemeral, single threaded channel. Hoof shear and browse pressure are reducing bank stability and vegetation coverage.*

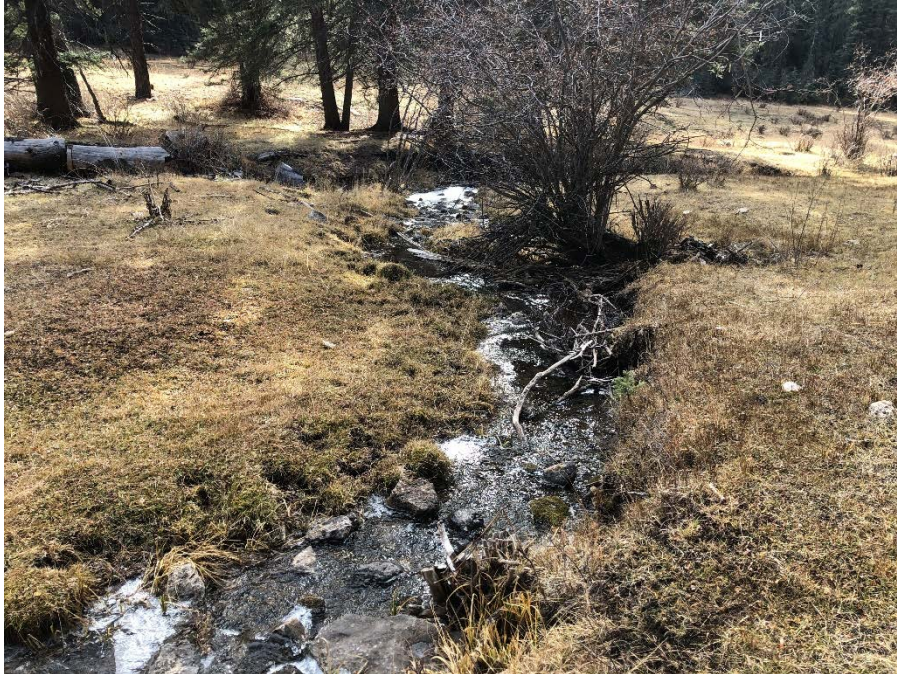
Figure 19. Cattle browse in a bedrock-controlled section of Rito Peñas Negras. Bebb's willow are found in this reach, but there is no natural recruitment.

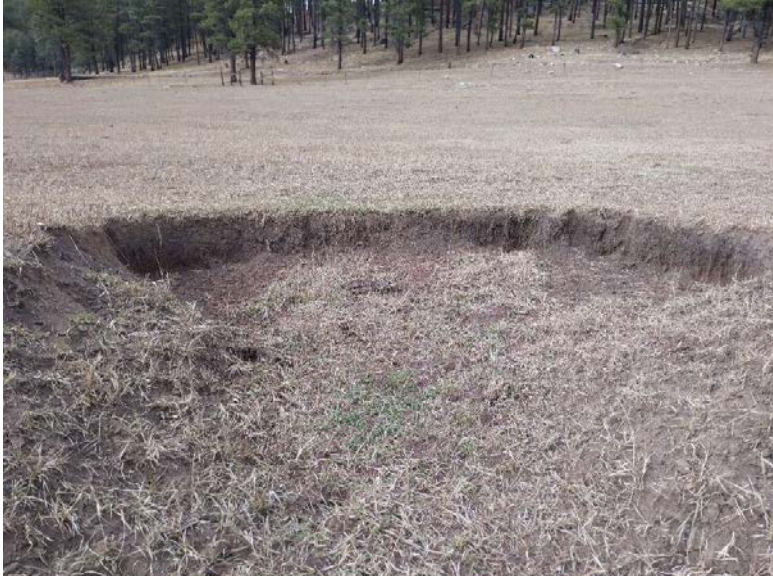
Figure 20. An active headcut migrating upslope in Sawmill Canyon, Rito Peñas Negras. High erosion rates are due in part to soil composition as well as extremely high cattle pressure reducing groundcover and disrupting soils.

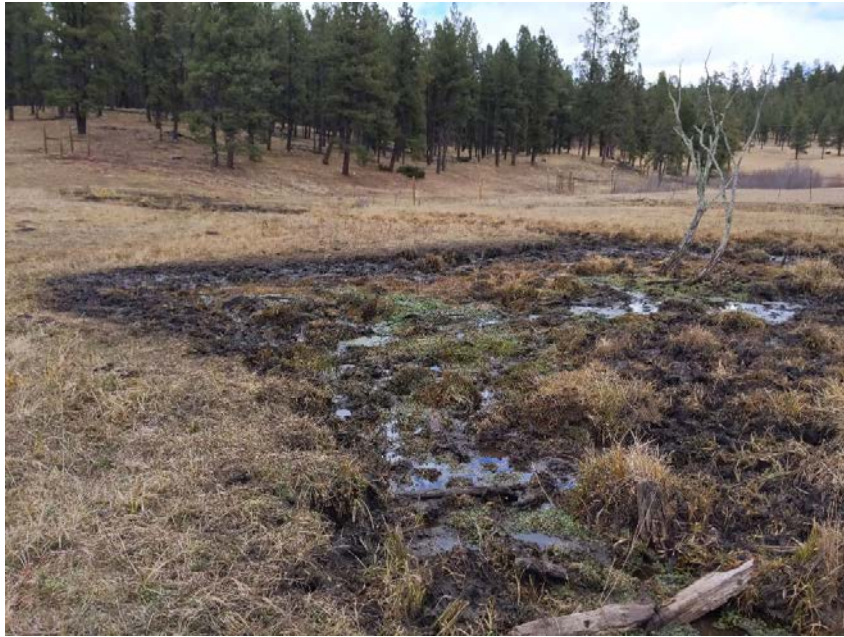
Figure 22. A spring-fed wetland complex in Rito Penas Negras, Sawmill Canyon. The wetland area is extremely degraded by cattle browse and hoof shear. Elk wallows are also present in the area.

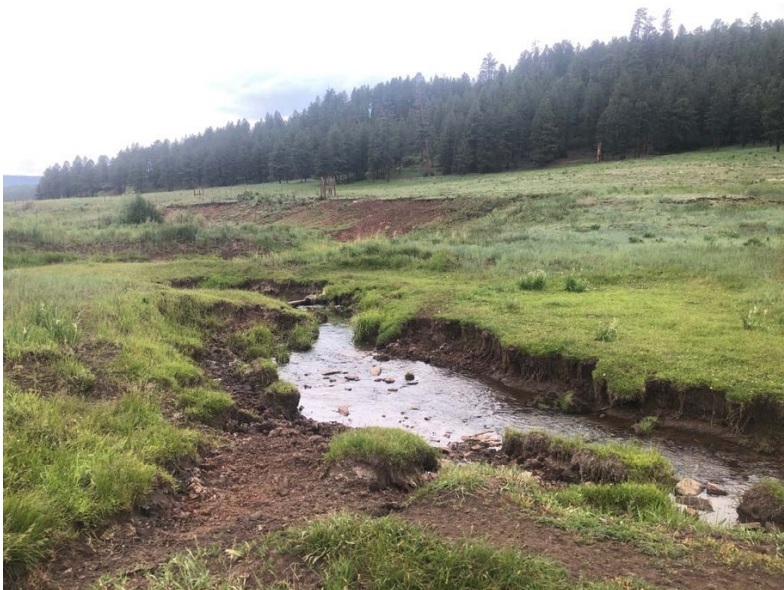
Figure 23. Extensive bank erosion on Rito Penas Negras outside of cattle and elk exclosures.

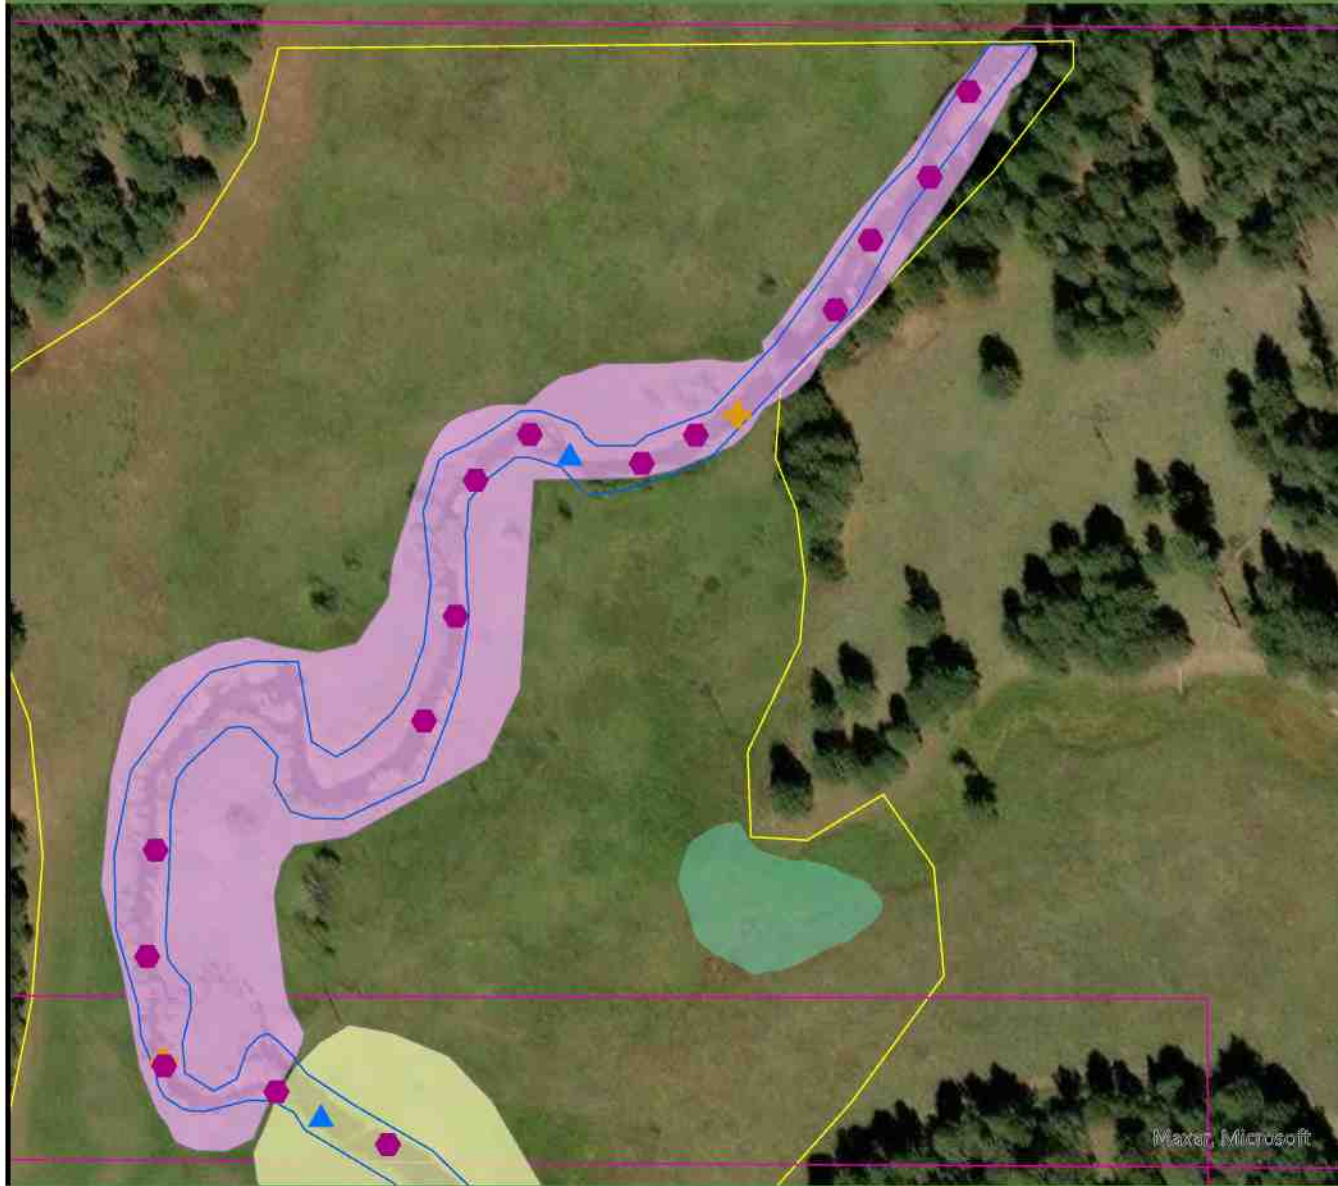
## Telephone Canyon Complex 1

Complex 1: Incised channel with narrow inset floodplain, lacks woody structure. Beaver dam blow out and partly rebuilt. PALS used to source sediment, widen, aggrade, and induce connection with floodplain.

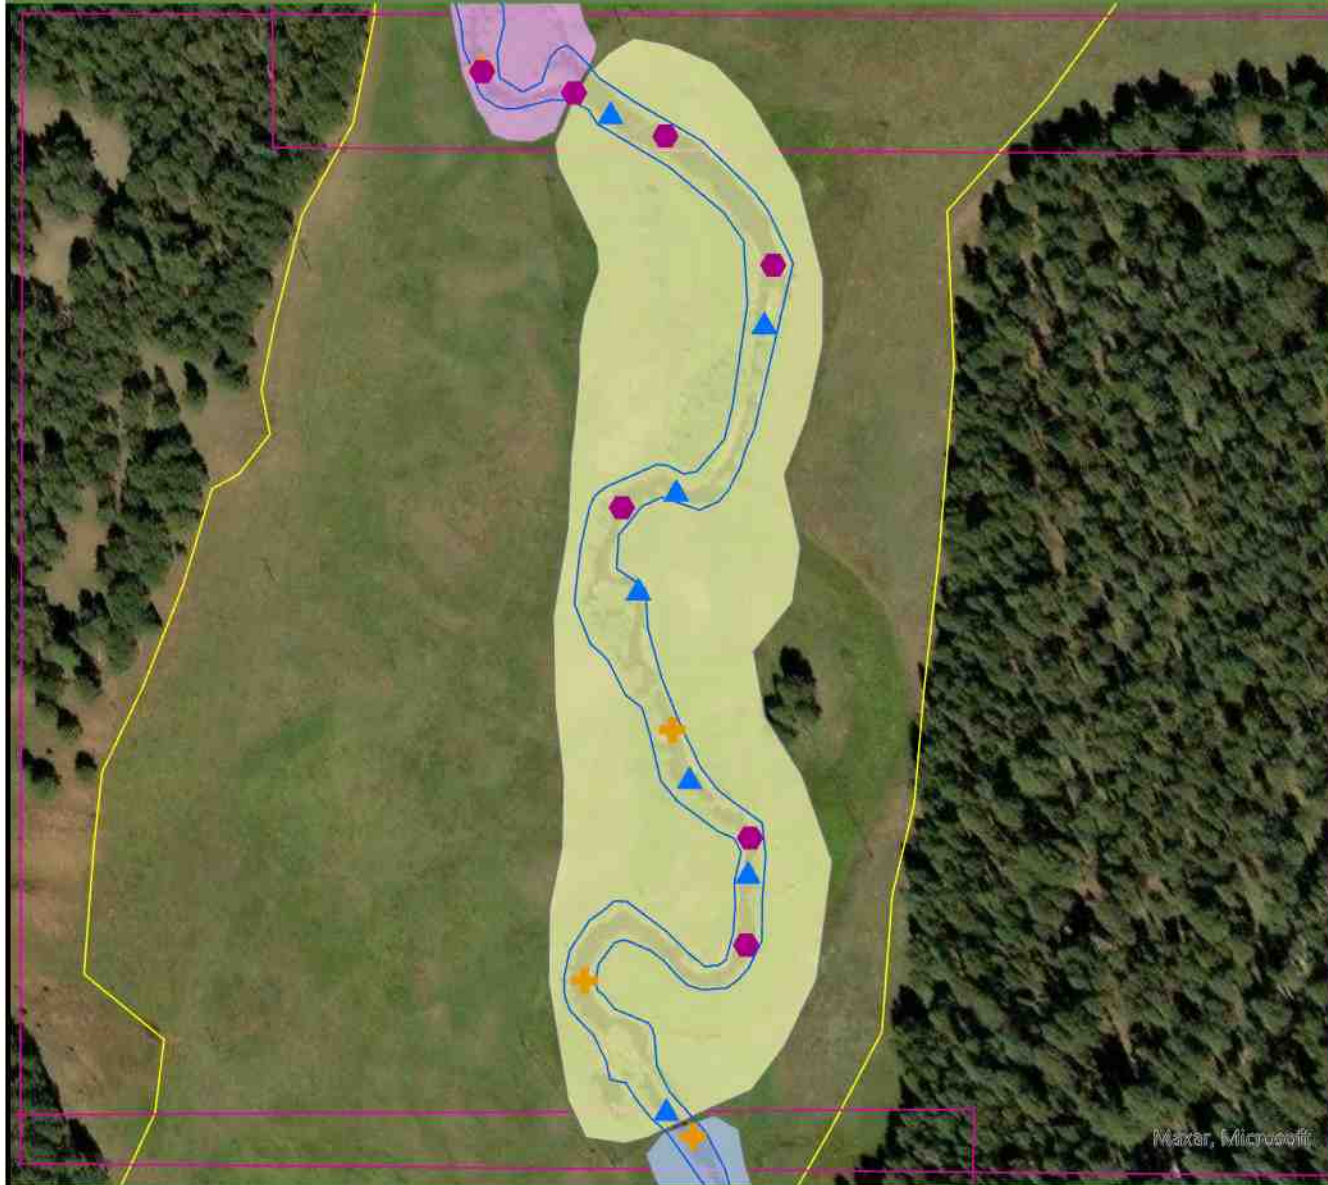
## Telephone Canyon Complex 2

Complex 2: Blown out beaver dam and current dam building activity. BDAs to improve habitat for beaver and PALS alternating with BDAs to source sediment, aggrade channel, and improve floodplain connectivity.
