Defenders of Wildlife Share with Wildlife Final Report

Project: Aquatic Habitat Connectivity Assessment for the Santa Fe National Forest

Contractor: Defenders of Wildlife; Subcontractor: Cascade Conservation, LLC.

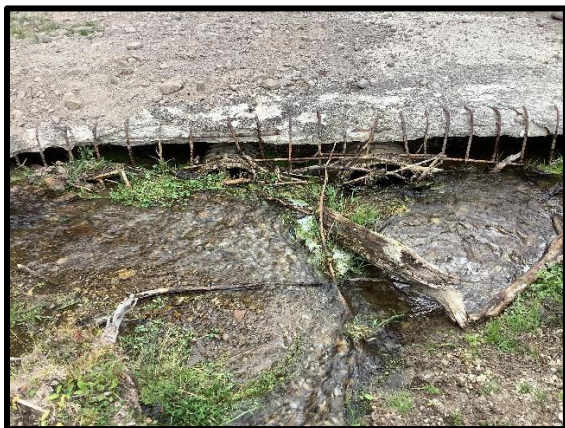
Of the 99 culverts assessed, 42 remain in good condition, 32 exist in fair condition, and 16 were determined to be in poor condition. Of those 16 poor culverts, one culvert intersected perennial water and justified immediate management action (Figure 1). Of the remaining 15 poorly rated culverts, seven are completely or almost completely blocked and require servicing to improve hydrologic functioning within the riparian and adjacent habitats. The last eight poorly rated culverts were disconnected from perennial water, and while they could provide habitat to amphibian SGCN, the need to address these culverts is primarily related to managing runoff adjacent to the roads these culverts run underneath (Figure 2).

Figure 1 Culvert number 115 on the Rio Cebolla (Photo credit: Cascade Conservation)

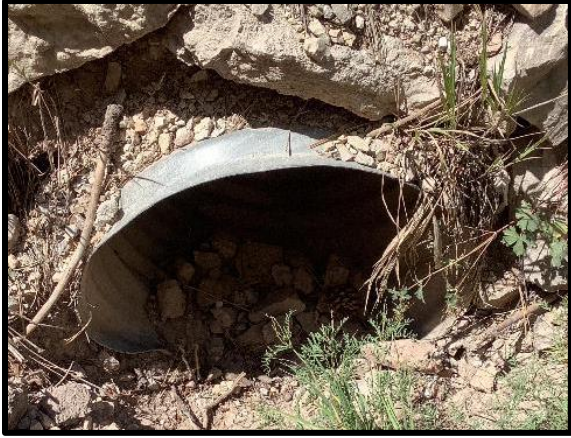
Figure 2 Figure 2. Culvert number 48 on the Rio de las Vacas (Photo credit: Cascade Conservation)
