# Rio de Las Vacas Riparian Restoration

Rio de las Vacas Design  
&  
Tributary Concept Design and Assessment

The section of the Rio de las Vacas between the FS 20 road crossing upstream to the private land boundary was assessed geospatially and surveyed on foot. An 80% design is included in this report for the section, which includes structure types and locations, recommended enclosure realignment, alluvial fan resets, and planting areas with complex objectives and anticipated zone of influence. The remainder of the tributaries and sections of the mainstem Rio de las Vacas were strictly assessed geospatially and verified through cross-checking with the Rio de las Vacas assessment report from 2021 (Whittlesey 2021), with the result being high-level concept designs.

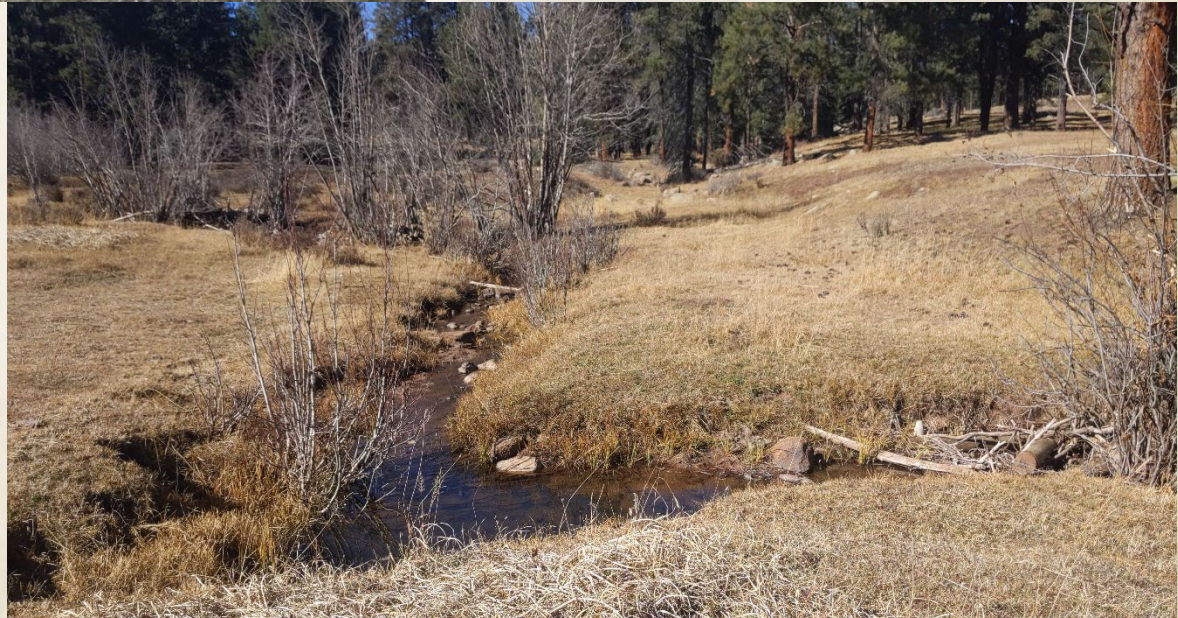
Limited Riparian  
Vegetation

Incised channels

Disconnected from  
floodplain

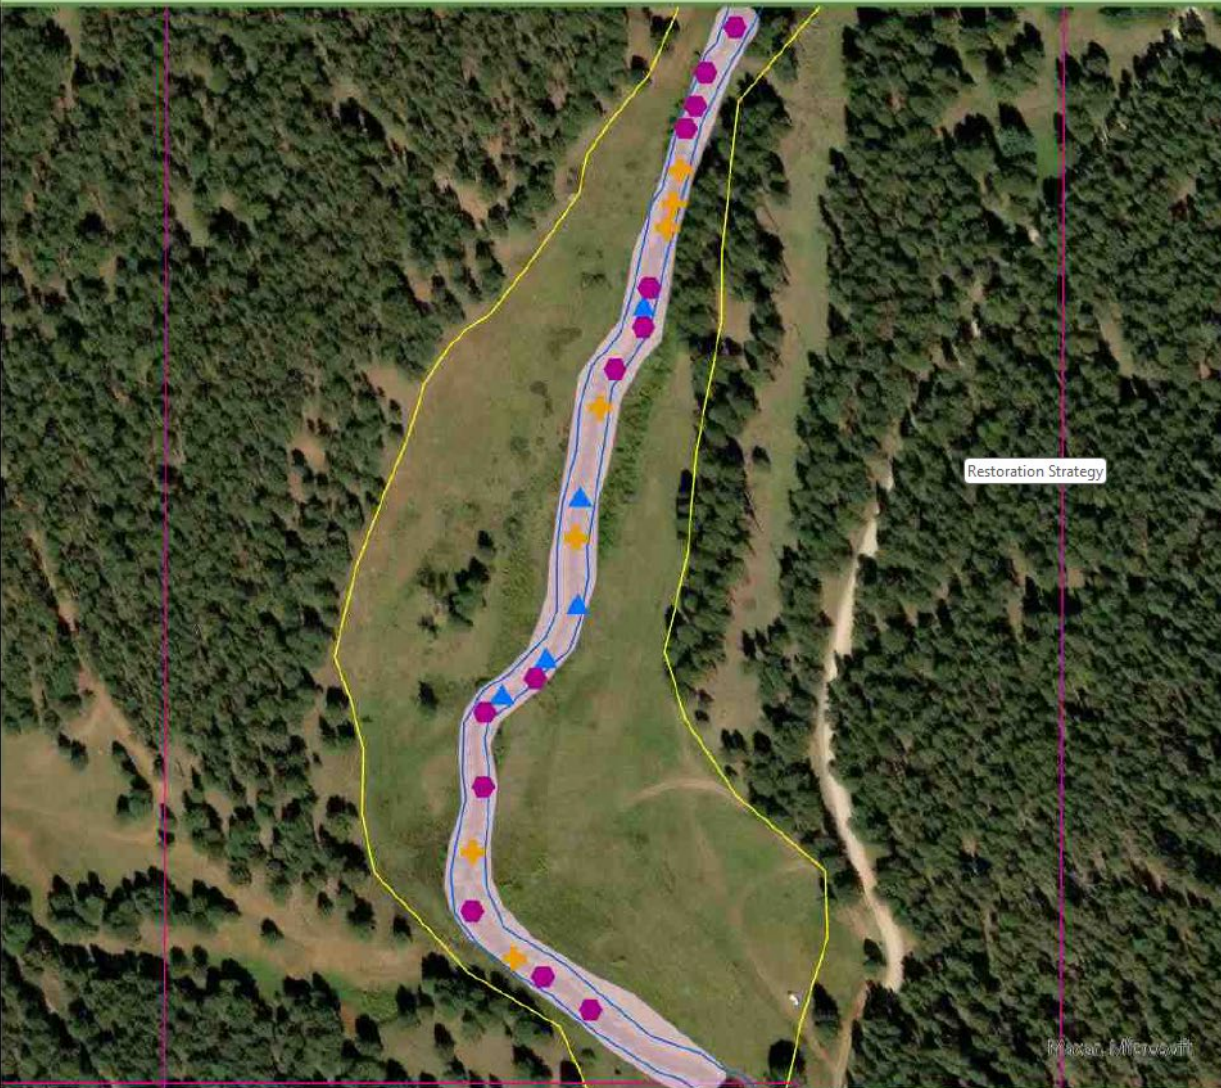
## Turkey Canyon Complex 1

Complex 1: A series of poorly connected inset floodplains. LWD and PAL structures to liberate sediment and induce overbank flows alternating with BDAs to aggrade channel and improve floodplain connectivity.

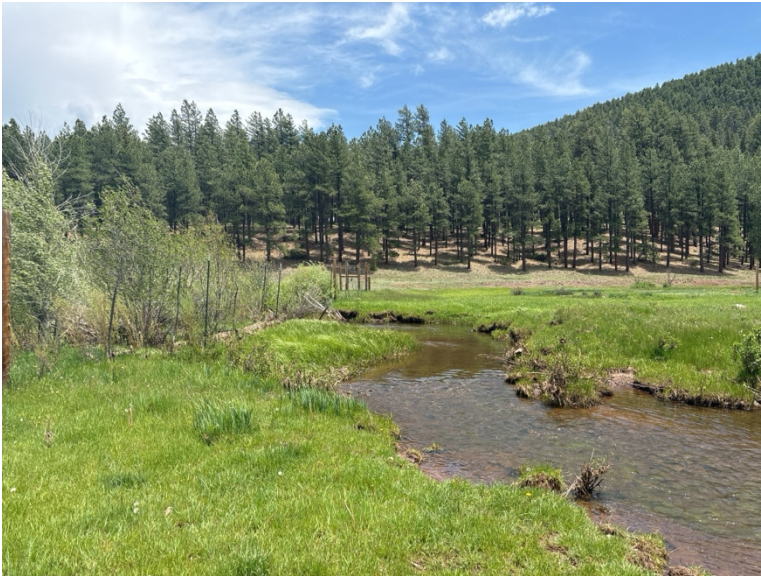
Figure 6. Planted deciduous riparian species are seen on the left side of the photo within the elk enclosure. Under the restoration plan, the plantings will be extended across the historic floodplain.

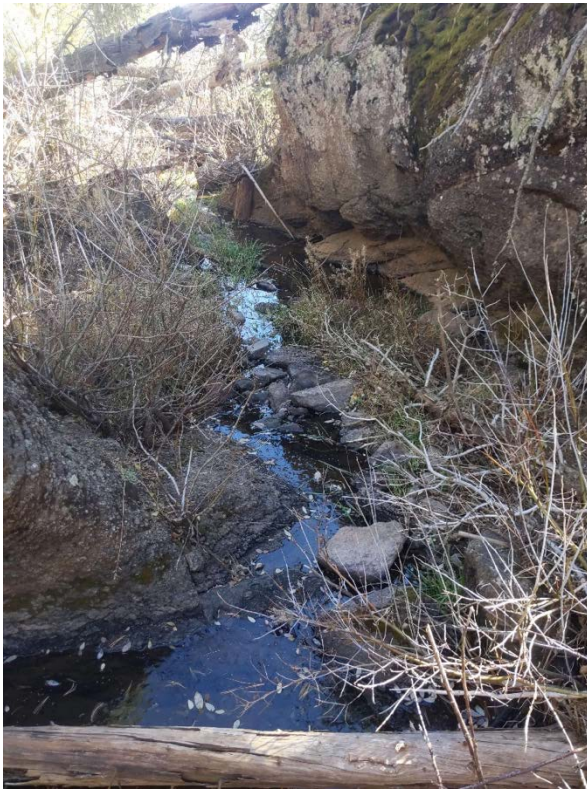
*Figure 11. A functionally intact reach of Clear Creek. A geologically confined condition has limited excessive browse pressure from elk and livestock.*

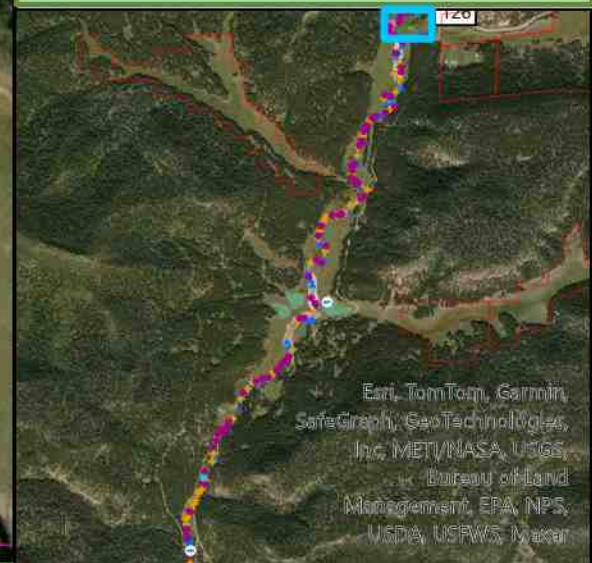
Complex 1: Incised channel with narrow inset floodplain, lacks woody structure. Beaver dam blow out and partly rebuilt. PALS used to source sediment, widen, aggrade, and induce connection with floodplain.

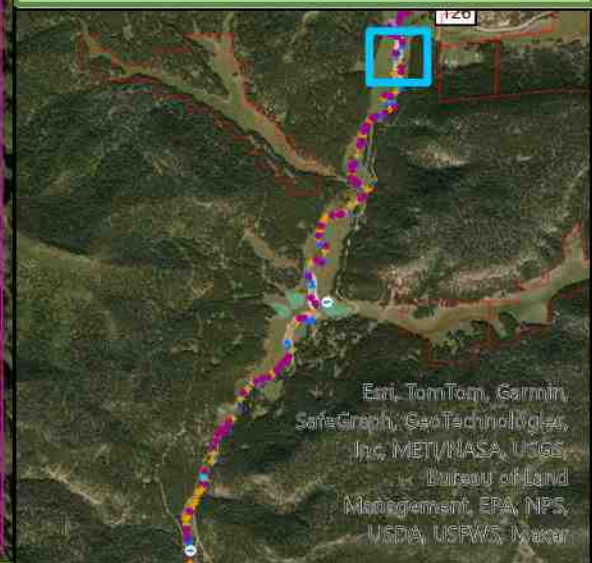
## Telephone Canyon Complex 2

Complex 2: Blown out beaver dam and current dam building activity. BDAs to improve habitat for beaver and PALS alternating with BDAs to source sediment, aggrade channel, and improve floodplain connectivity.

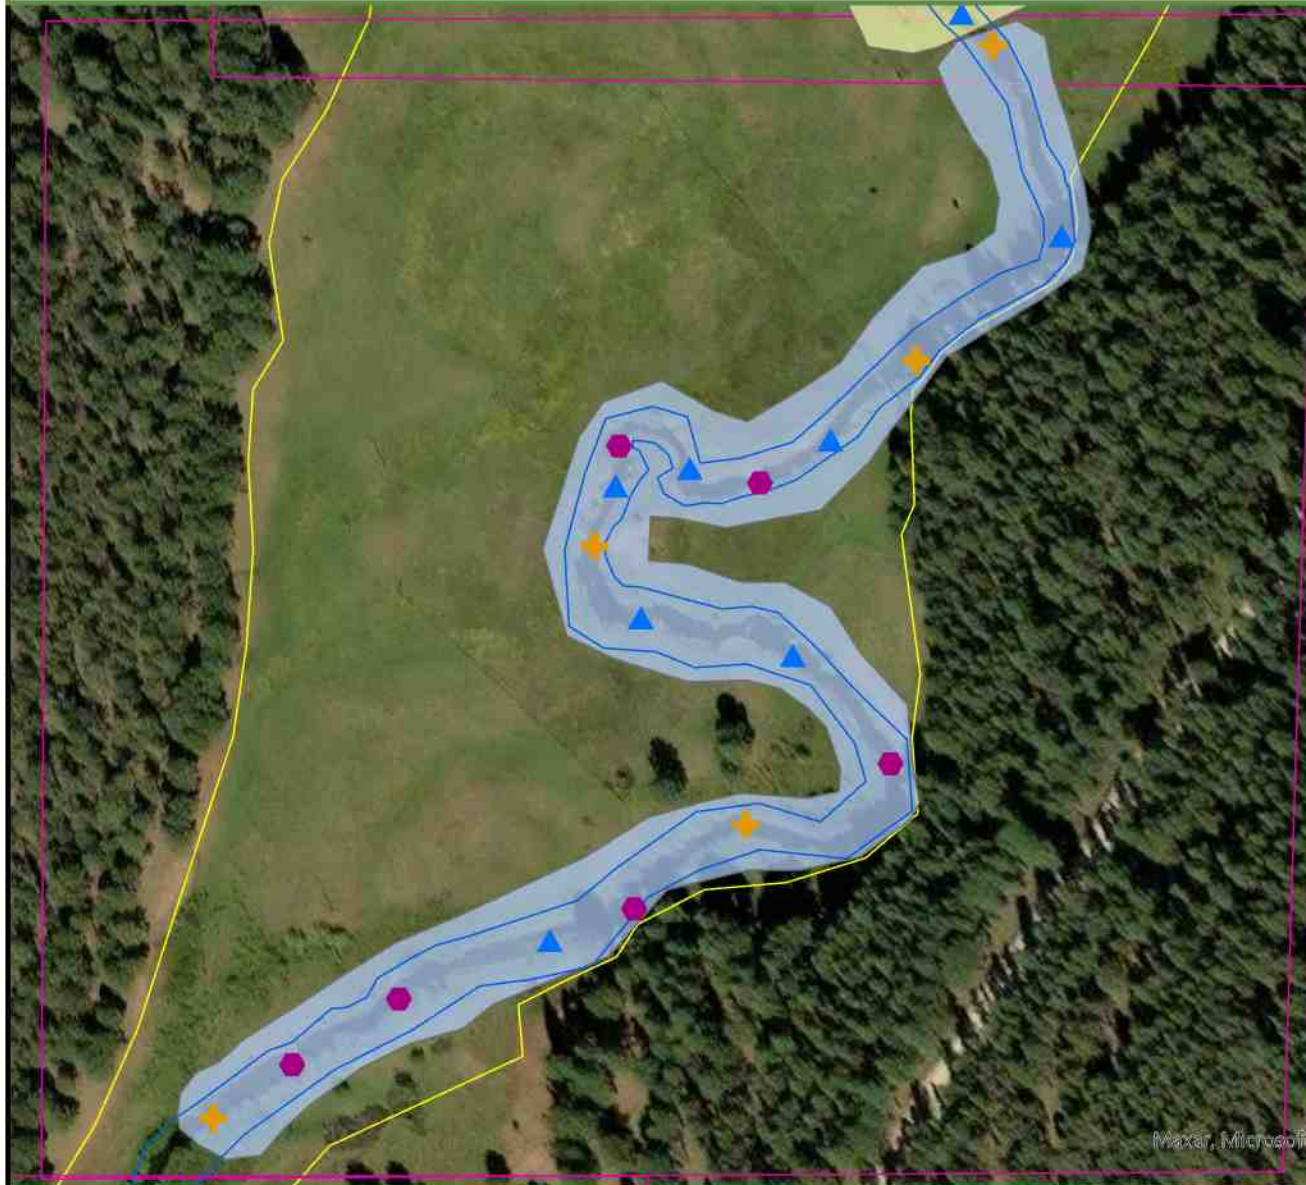
## Telephone Canyon Complex 3

Complex 3: Channel incised with narrow inset floodplain and lacks woody structure. LWD and PAL structures to liberate sediment and induce overbank flows alternating with BDAs to aggrade channel and improve floodplain connectivity.

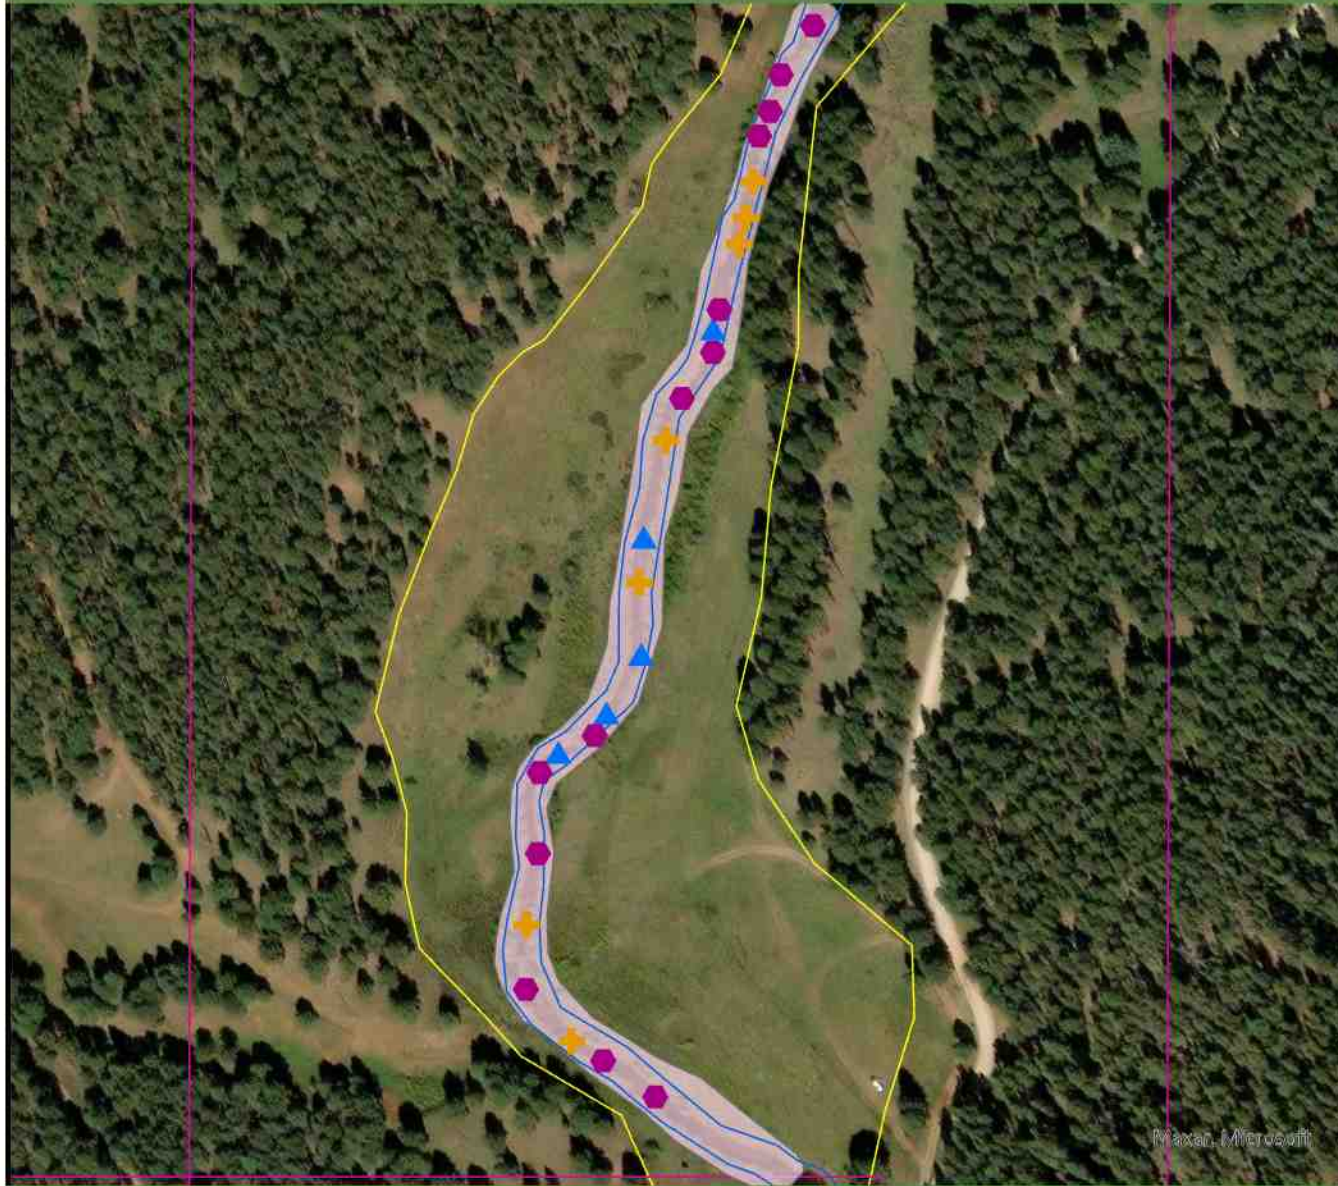
## Turkey Canyon Complex 1

Complex 1: A series of poorly connected inset floodplains. LWD and PAL structures to liberate sediment and induce overbank flows alternating with BDAs to aggrade channel and improve floodplain connectivity.
