Stewart Meadows Habitat Assessment & Conceptual Design

Rio Arriba County, New Mexico

PROJECT PHASE: 70% Design Plans

DRAWING:
Upstream Project Area
Assessment Overview

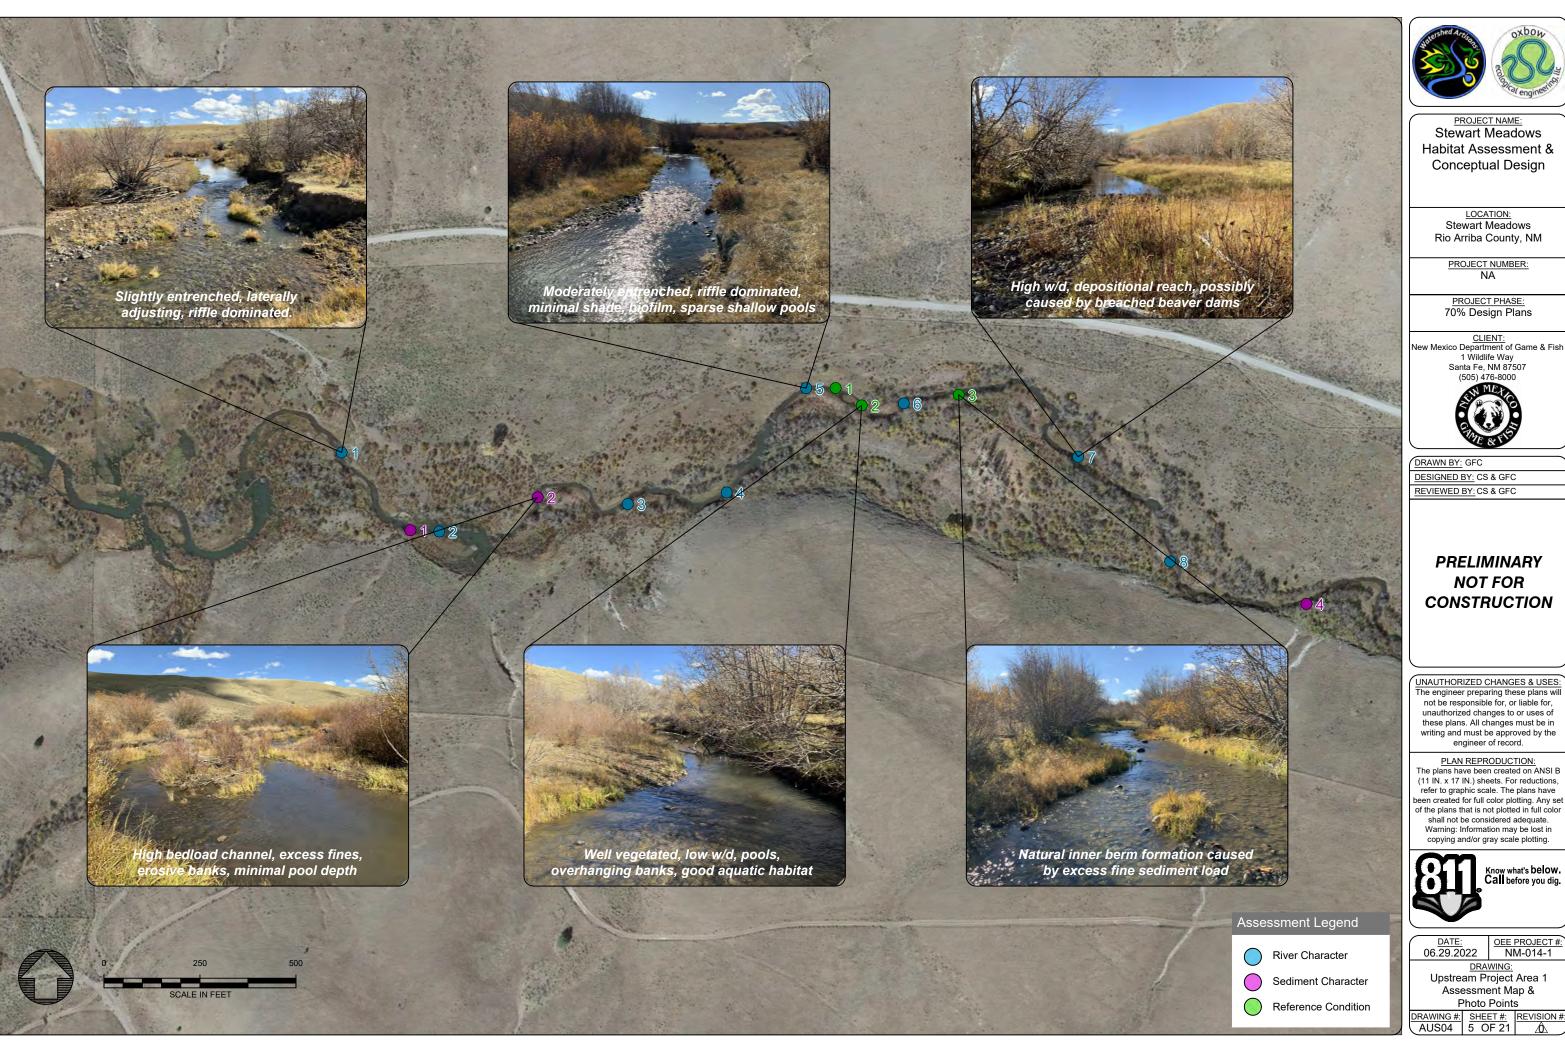
1	Sediment character	Excess hoof sheer on sandy erosive banks, trampling of deposited fines limiting colonization by wetland species, biofilm, high w/d		
2	Sediment character	High bedload channel, excess fines, erosive banks, minimal pool depth		
3	Sediment character	Excess fine sediment load, eroding terrace high bank h=5' l=200'		
4	Sediment character	Fining of sediment caliber in a downstream direction		
Reference Condition				
1	Reference condition	Woody recruitment on eroding bank, alders and willows		
2	Reference condition	Well vegetated, low w/d, pools, overhanging banks, good aquatic habitat

1 Signs of Degradation. Excess hoof sheer on sandy erosive banks, trampling of deposited fines limiting colonization by wetland species, biofilm, high w/d ratio

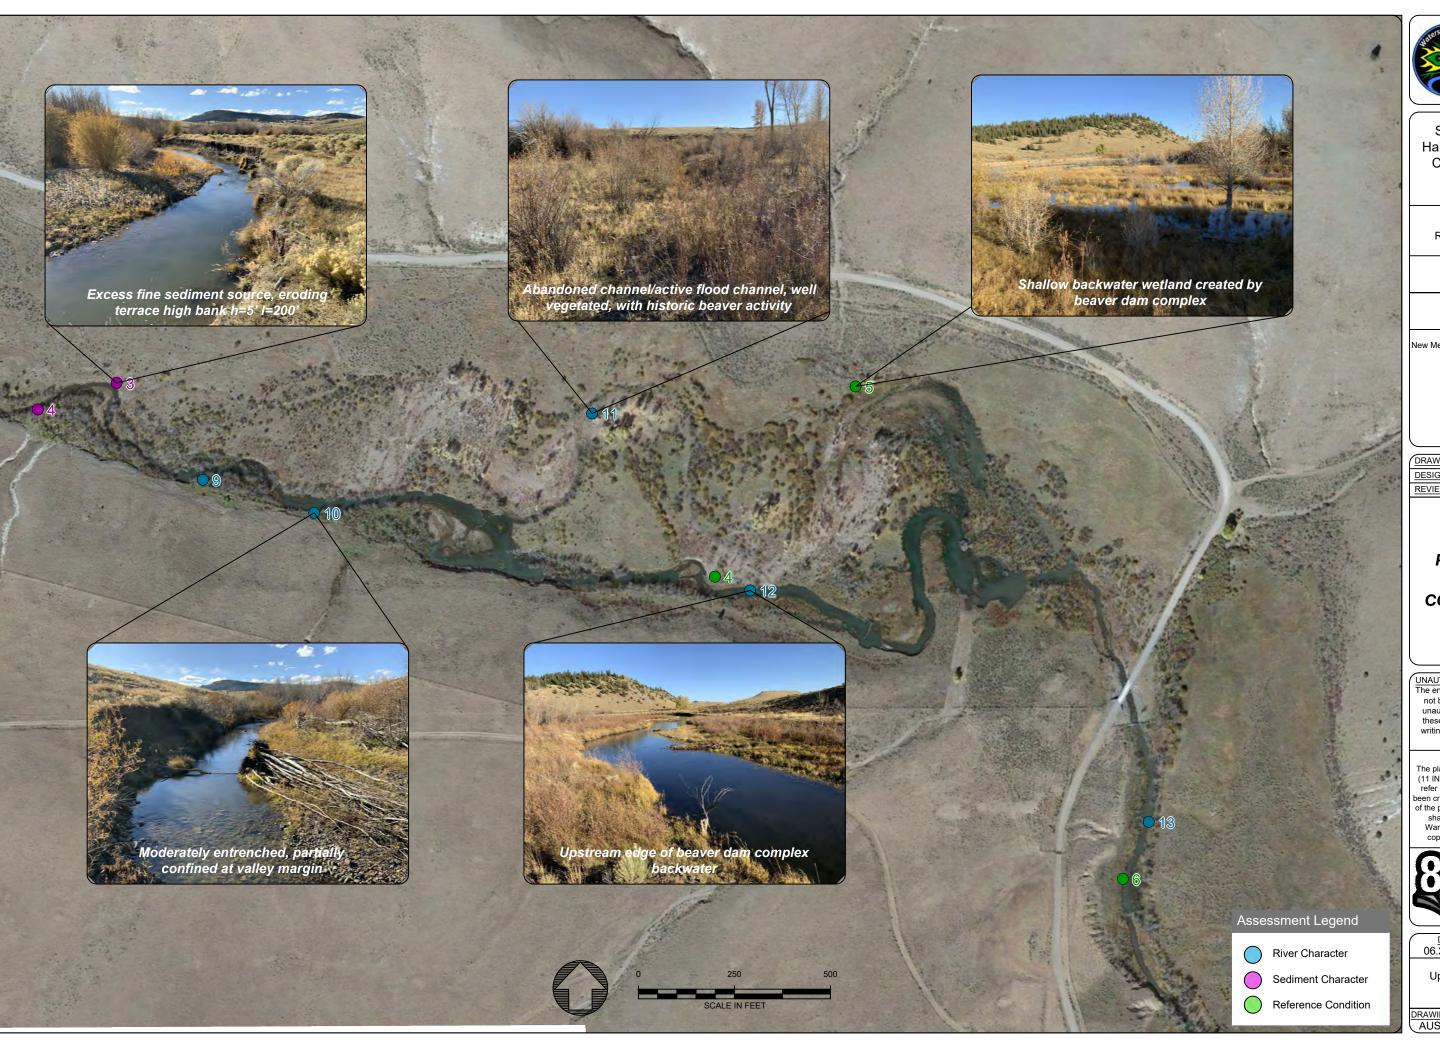
Upstream Project Area 2					
River Character					
9	River character	Moderately entrenched, partially confined			
10	River character	Moderately/ highly entrenched, high w/d, riffle dominated			
11	River character	Abandoned channel/active flood channel, well vegetated, historic beaver activity			
12	River character	Upstream edge of backwater from beaver complex			
		Sediment Character			
3	Sediment character Excess fine sediment load, eroding terrace high bank h=5' l=200'				
4	Sediment character Fining of sediment caliber in a downstream direction				
Reference Condition					
4	Reference condition Large beaver dam breach and channel relocation				
5	Reference condition Shallow backwater wetland

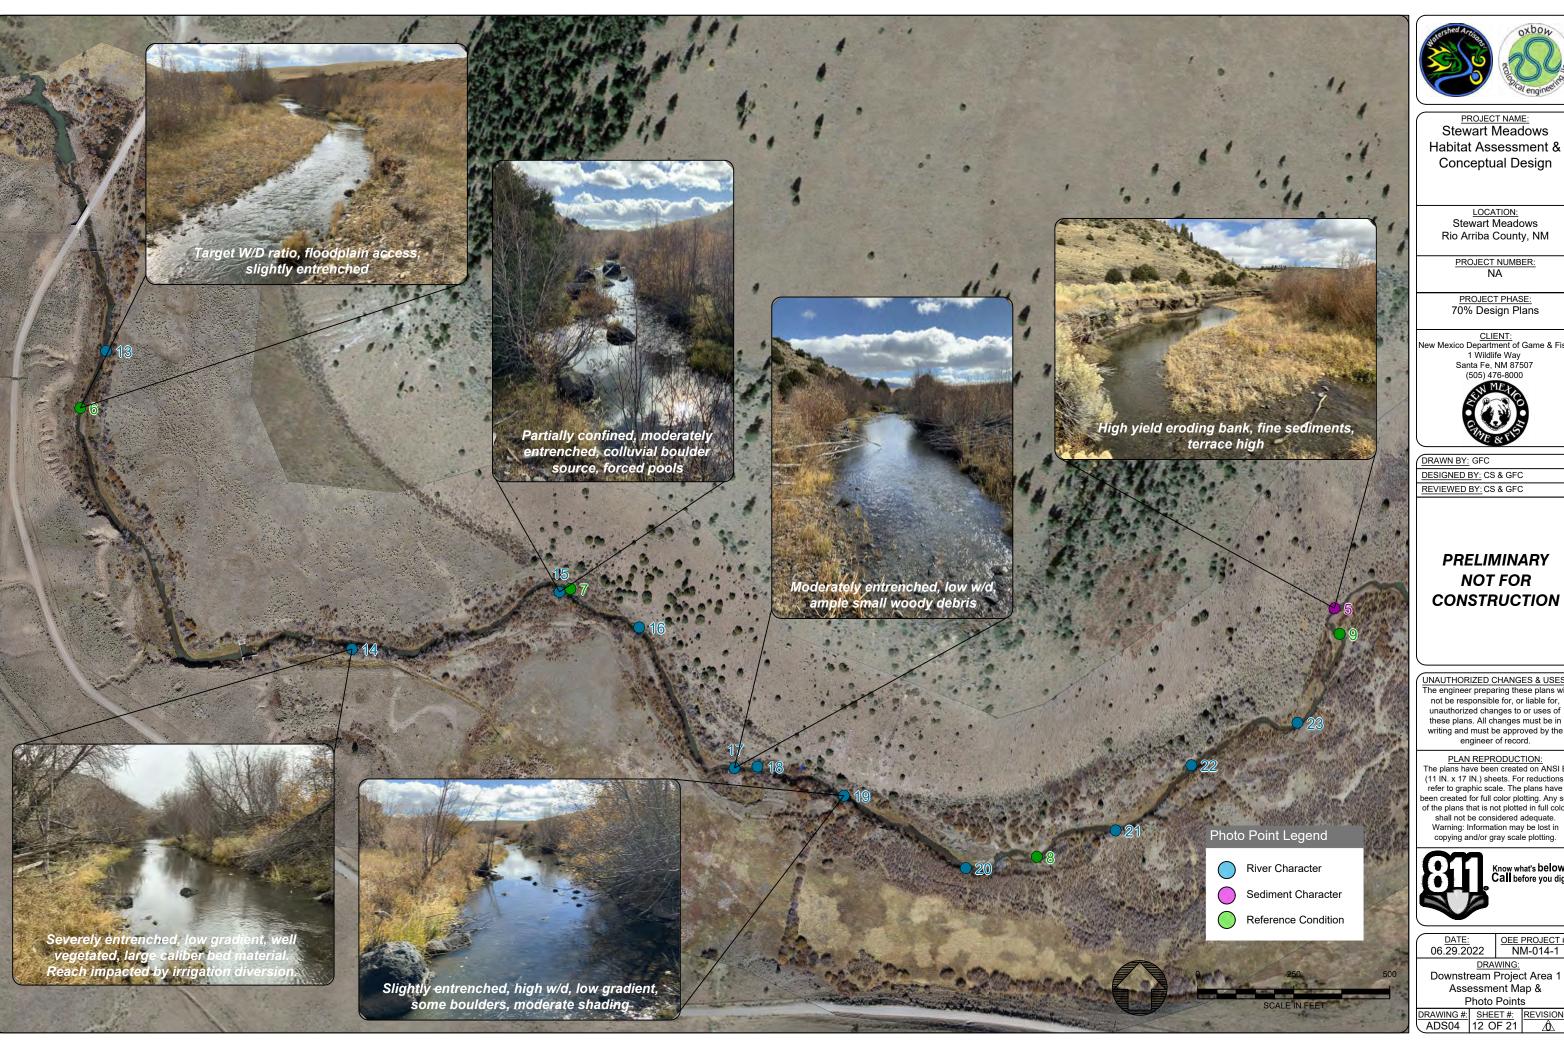
22	River character	Moderately entrenched, high w/d, plane bed, biofilm, smaller caliber bed material, poorly shaded	
23	River character	Slightly entrenched, moderate w/d, evolving meanders, unconsolidated alluvial bank material	
		Sediment Character	
5	Sediment character	High yield eroding bank, fine sediments, terrace high	
		Reference Condition	
6	Reference condition	Good w/d, short reach	
7	Reference condition	Boulder assisted log jam, small diameter alder	
8	Reference condition	Natural small diameter log jam	
9	Reference condition	Very deep pool, 4'+

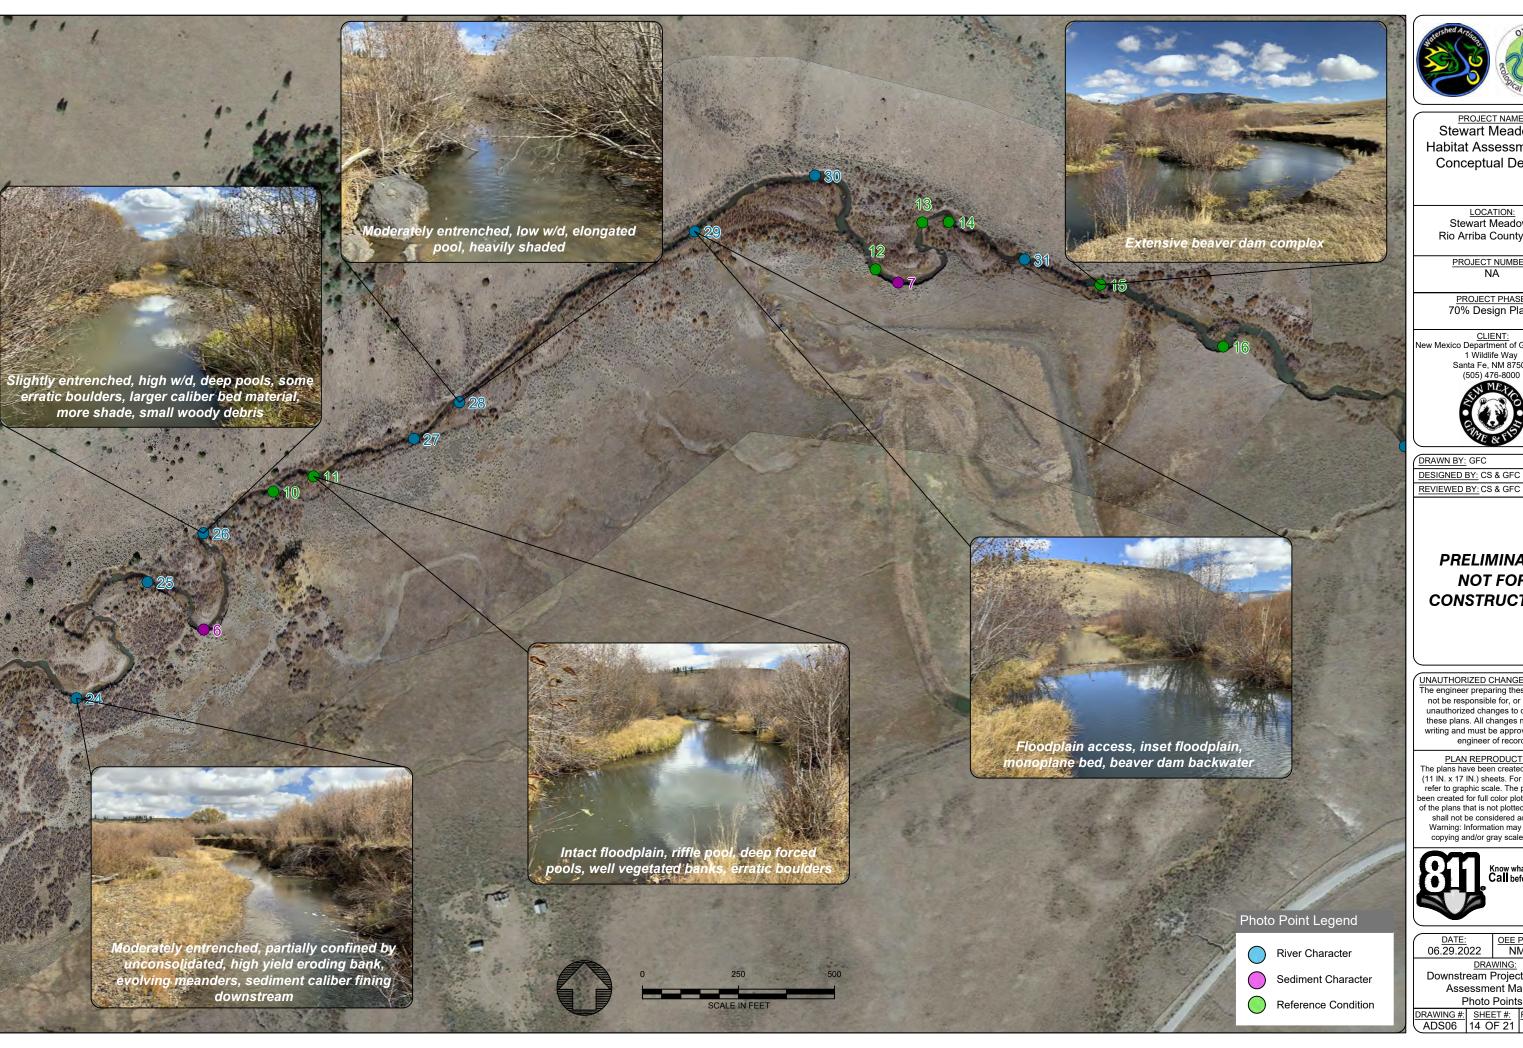
32	River character	Beaver dam complex			
33	River character	Evolving meanders, beaver dam complex			
34	River character	Evolving meanders, beaver dam complex			
		Sediment Character			
6	Sediment character	8' tall eroding bank, fine sediment			
7	Sediment character	10'+ eroding bank, fine sediment source			
Reference Condition					
10	Reference condition	Cross channel log jam			
11	Reference condition	Intact floodplain, riffle pool, deep forced pools, decent vegetation, erratic boulders			
12	Reference condition	Beaver dam with extensive backwater
