FY 2025 Wildlife Habitat Restoration Project Opportunity

Soda Springs Restoration

Soda Spring Restoration Project

Soda Spring Project

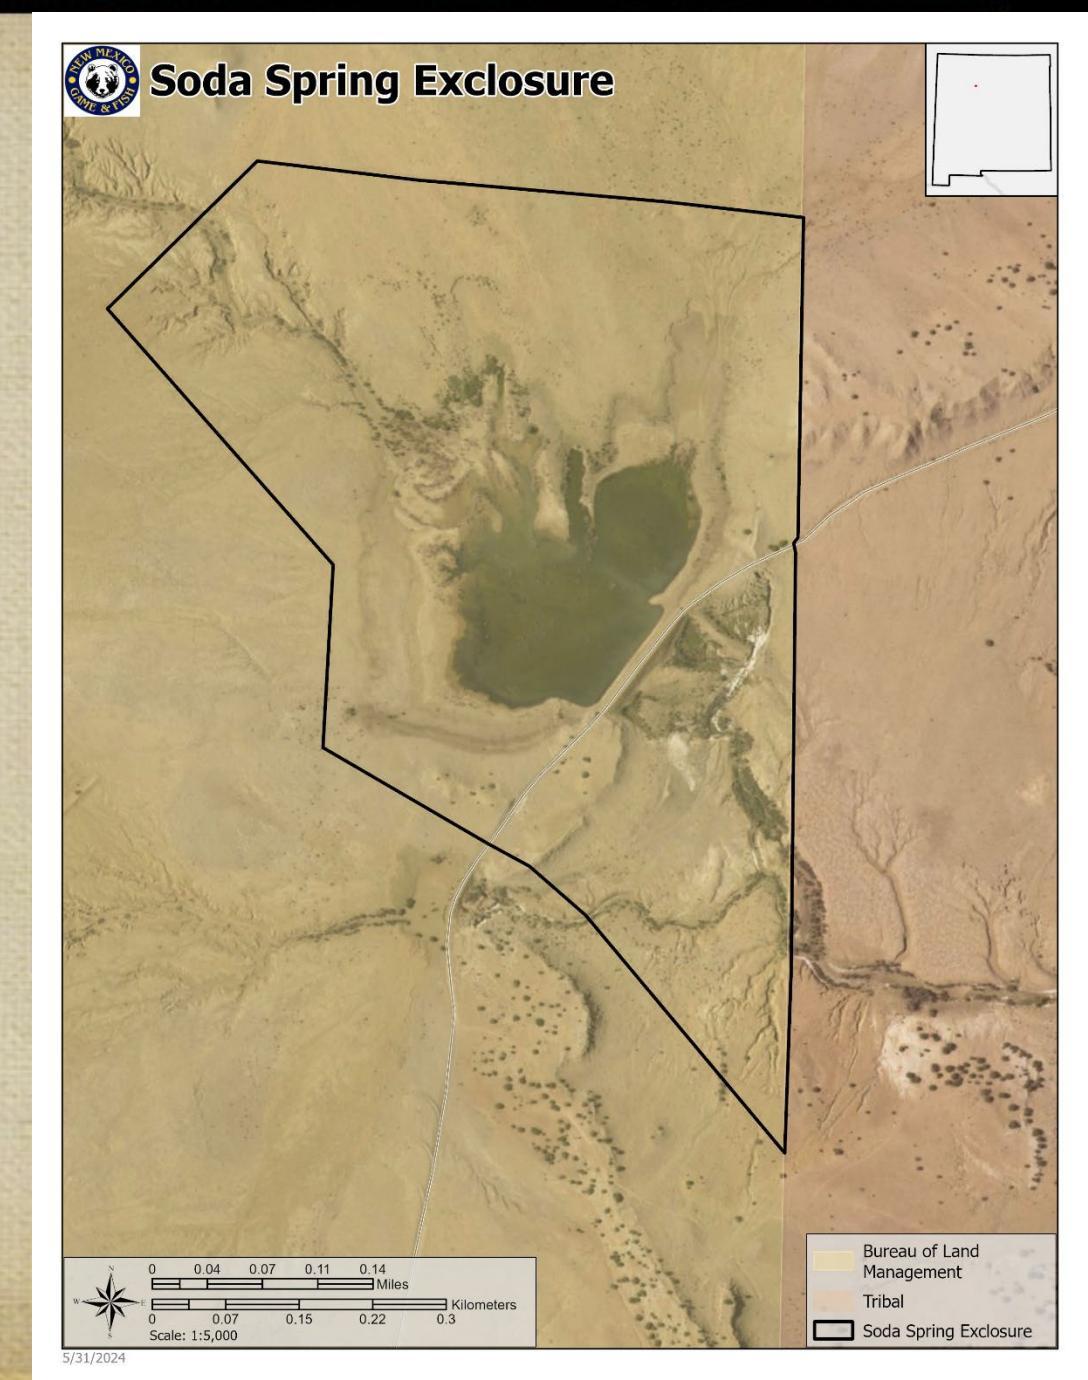
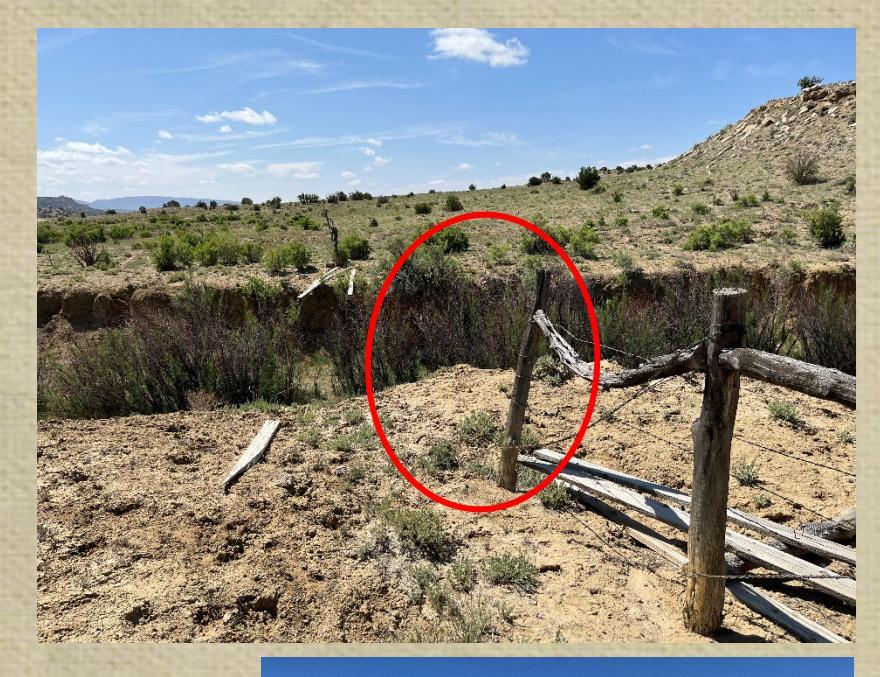
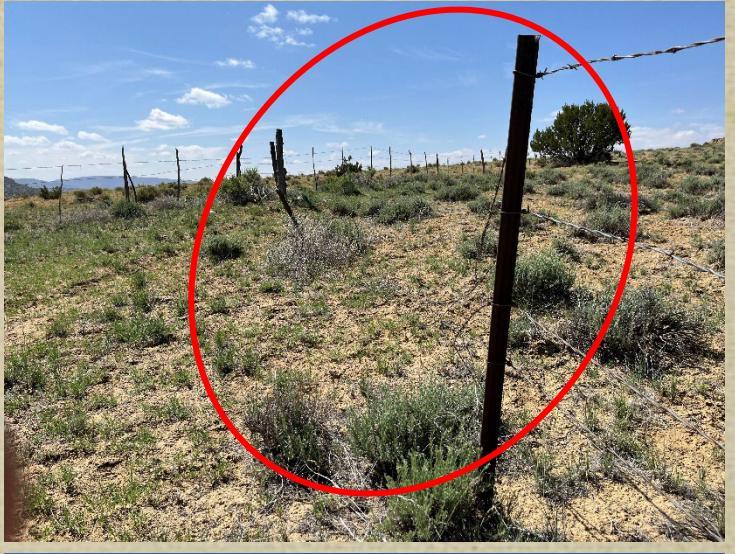
The present barbed wire exclosure experiences too much livestock pressure to remain effective despite maintenance efforts from BLM. Posts are knocked over, barbed wire is cut, and strands are missing in numerous locations. Currently not an effective riparian exclosure.

Replace the present barbed wire fence with a pipe and cable fence that requires little to no maintenance and will prevent livestock from accessing this area, giving the riparian habitat time to recover, conserving it for wildlife use, and providing wildlife with easier access.

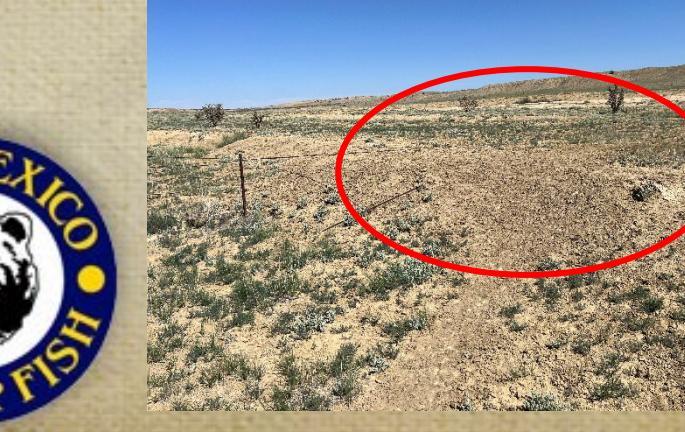
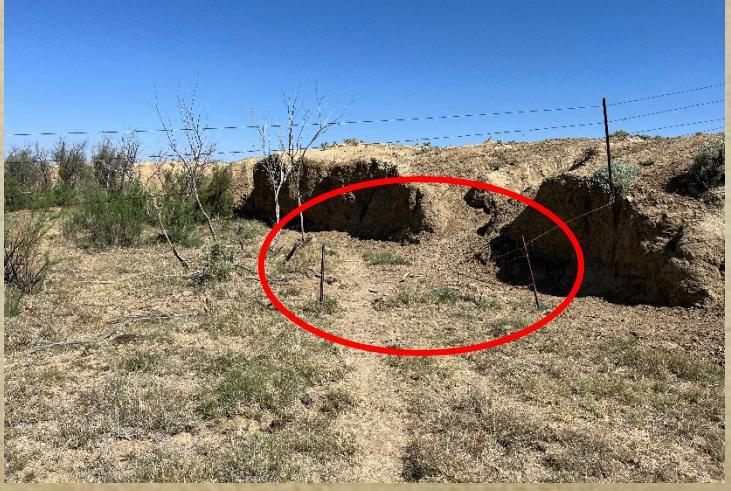
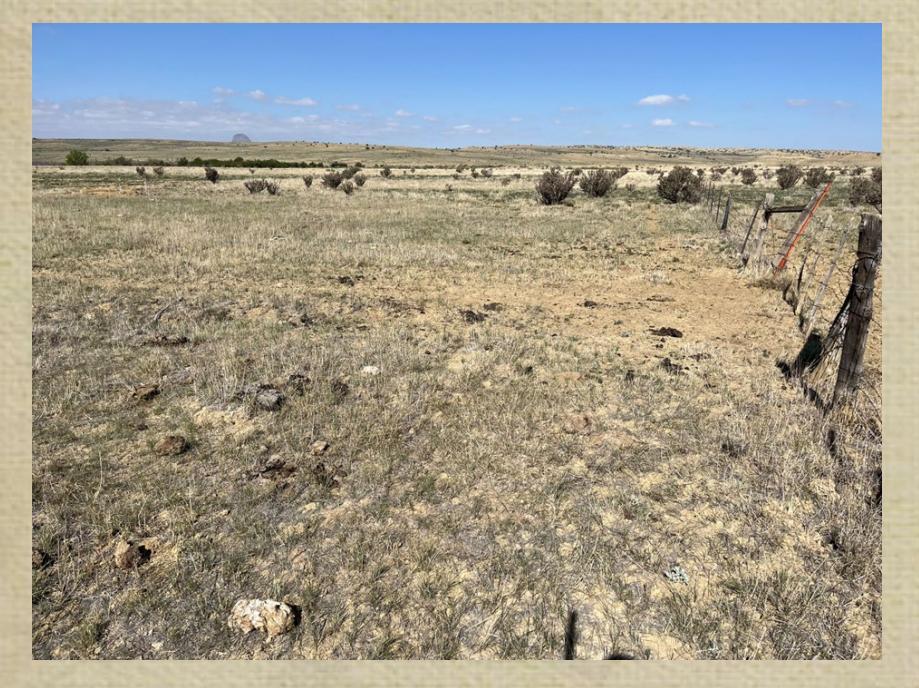
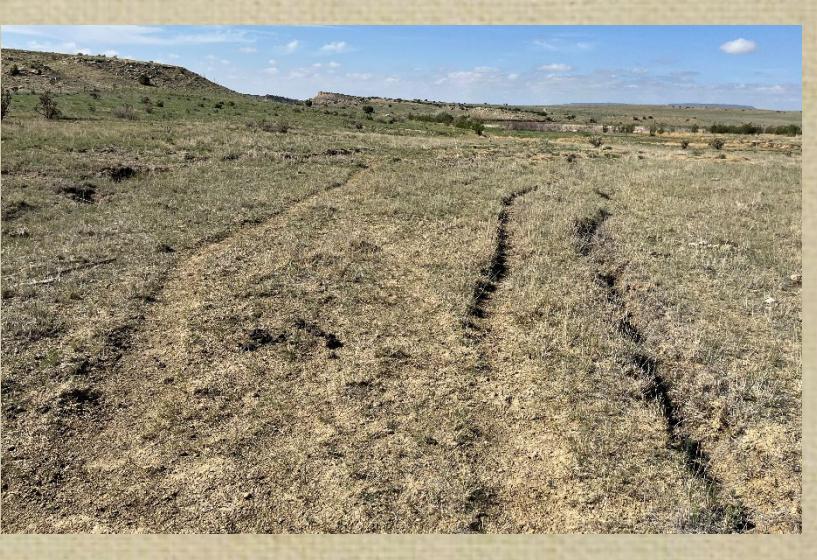
The non functional exclosure has led to heavy livestock pressure near this sensitive riparian habitat and water source, overgrazing of grasses and forbs, cow trails that cause erosion and downcutting, and disturbed soil paving the way for invasive establishment.

After completion of the pipe and cable fence, invasive plants (salt cedar, Russian olive, etc.) shall be mechanically and chemically removed. Slash from removed woody vegetation will then be piled, dried, and used for erosion control or burned.

Following invasive removal, native vegetation will be seeded, and planted as cuttings and container plants.
